In the lead up to Christmas last year, there was a terrible accident involving a large truck mounted elevated work platform. Shortly after the tragic accident, Qld Workplace Health and Safety issued a Safety Alert regarding the support of mobile plant on outriggers, with particular mention of being aware of soft ground.

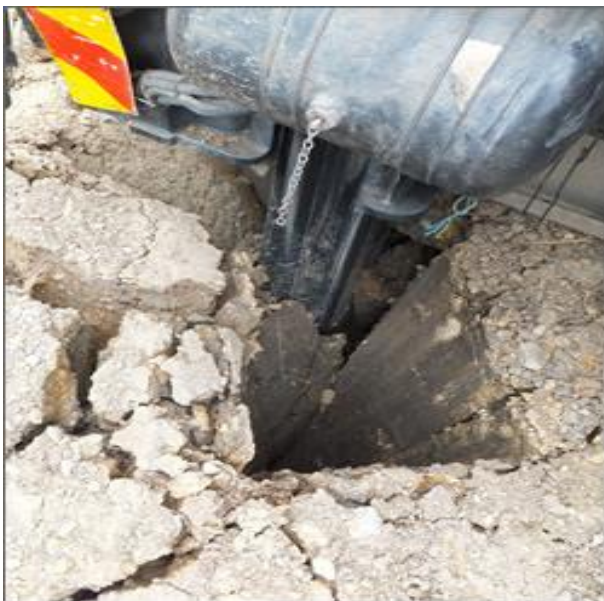
The photo above is from the QLD WHS Safety Alert which can be found at this link:

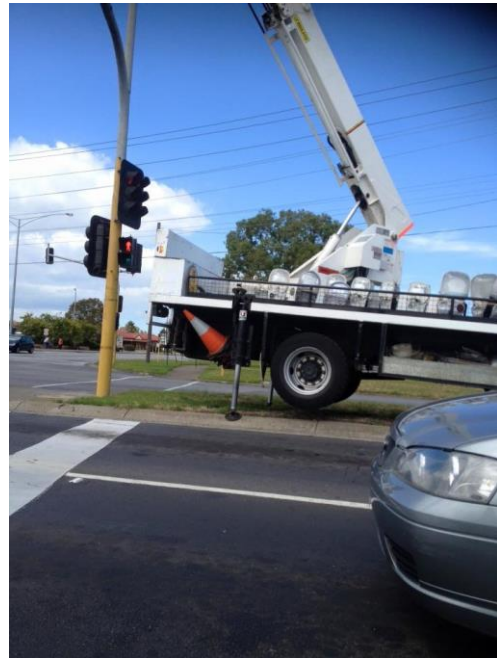
A week into the New Year and only two weeks after the alert was issued by Qld WHS, these pictures surfaced of a similar machine being operated in Melbourne.

Whilst the size of the machine maybe a little smaller, the end result could easily be the same. Outriggers and stabilizers on cranes are not there for sitting on when things are quiet; they are an integral part of the safety of the machines they are attached to, regardless if it is a mobile crane, an EWP or telehandler etc – They should be used correctly!

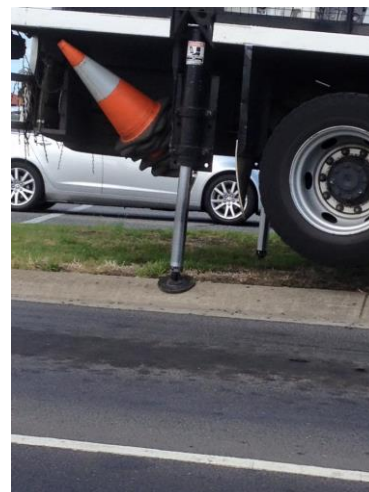
*The likelihood of that outrigger foot slipping on the concrete curbing is fairly high if the machine is subjected to rough operating – which one may assume is highly likely considering the way the machine is set up.*
