Today's topic is **pinning of outrigger beams**.

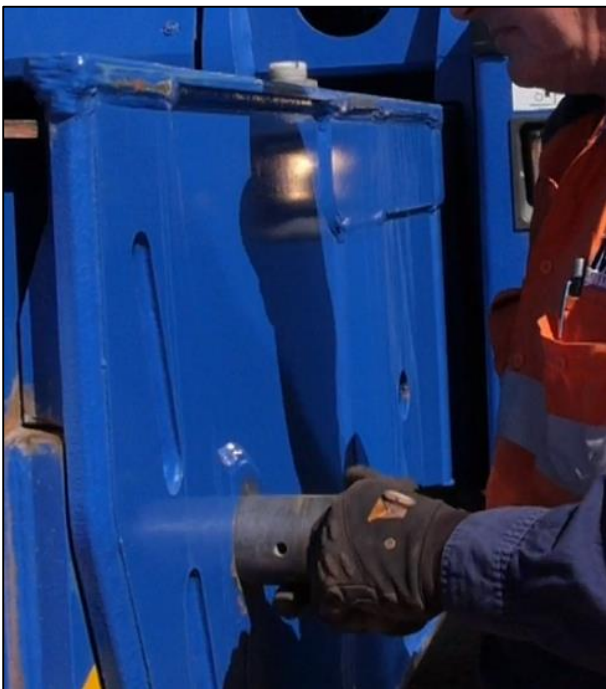
Locking pins should always be used when supplied.

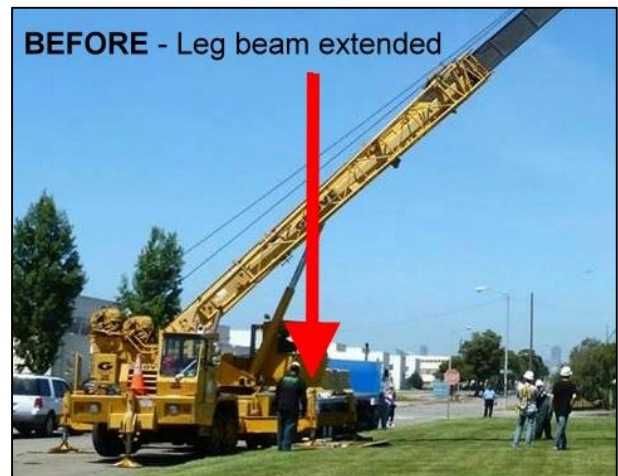
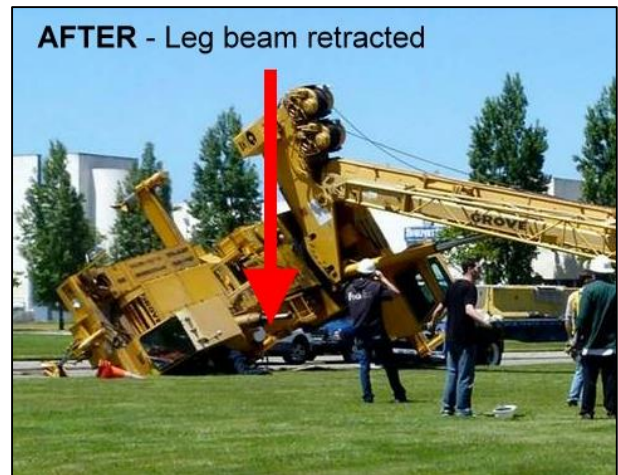
In the 2 photos that follow, the “before” photo shows the crane is set up with all leg beams extended, but the “after” photo (with the crane

tipped) shows that the front left side beam is now retracted. What we can't be sure of - did the crane tip because the leg retracted, or did the leg retract when the crane started to tip?

However, whichever the case, the leg beam was obviously not pinned. If it was, this incident may have been avoided.

If your crane has pins to lock the outrigger extensions, make sure they are always used, as this is what the manufacturer intended for safe use.
